CONSULTING STRUCTURAL ENGINEER, INC.

May 27, 2016

Re: Structural Inspection of the Island Theatre at 1 Circuit Avenue, Oak Bluffs, MA

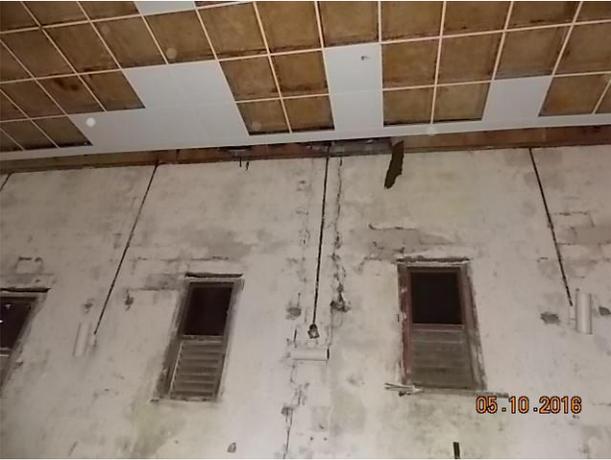
The building is constructed with timber roof trusses spanning 51' at 8'9" o/c supported by 16"x16" concrete masonry unit (CMU) pilasters and 8" thick concrete masonry unit walls up to 18' tall. The observed CMU pilasters and walls are hollow and unreinforced. The masonry block walls are interlaced in running bond on the east side of pilaster courses; however, the walls are not mechanically anchored to the timber roof plate and significant gaps exist up to 1/4" wide in the butted joints on the west side of the pilasters and the gaps are visible on both the interior and exterior of the building (see photo 1, 2, 3 and 4).

The concrete masonry unit walls are part of both the gravity and lateral force resisting systems and are a critical structural component necessary to support the service loads. Cracks and gaps at the junction between the walls and pilasters are evidence that the building is detached with differential movement due to service loads and represents a significant risk of future additional detachment and/or dislodgment, since the walls are unreinforced and not mechanically anchored to the roof framing at the top of the walls.

1) Gaps in the masonry wall at each pilaster

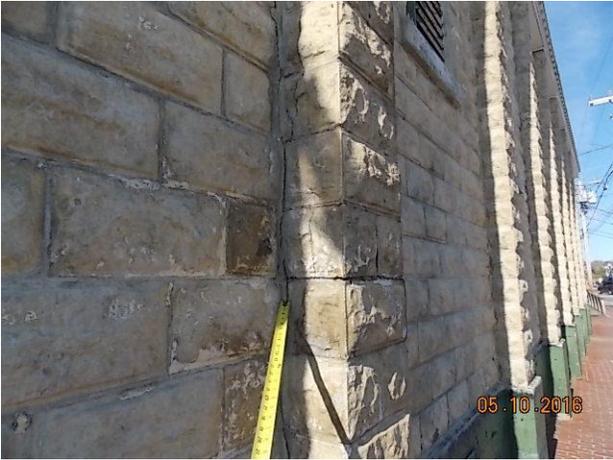
2) Gap between the masonry wall and pilaster

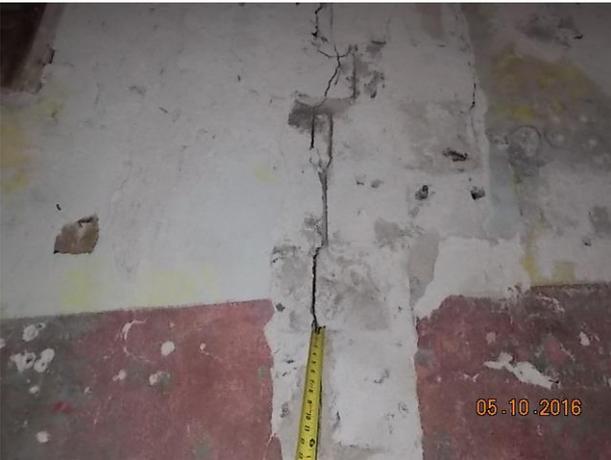
3) Gap along the west side of masonry pilaster

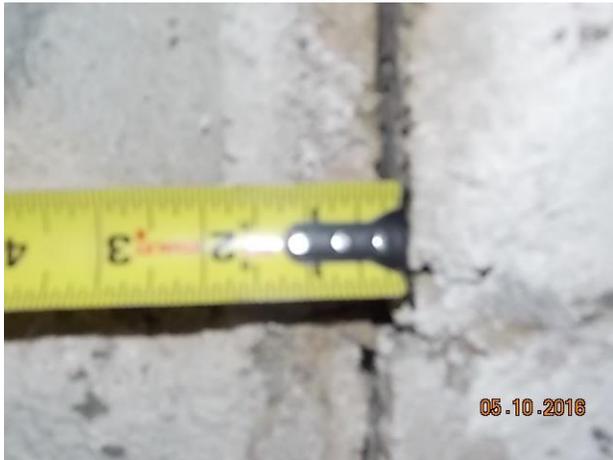
4) Gap between masonry block wall and pilaster

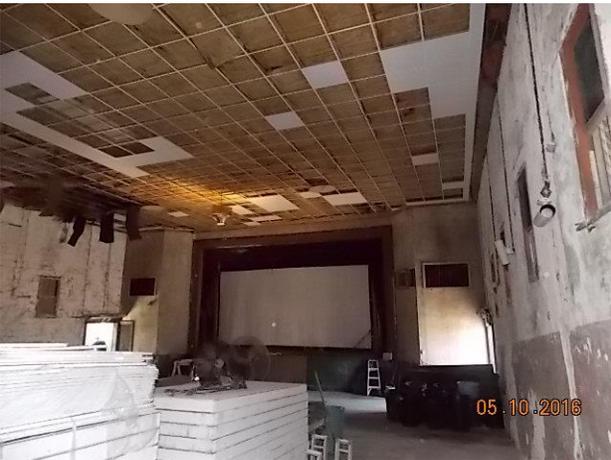
According to the owner, the building has been vacant since 2012, roof repairs designed by the engineer of record Reid Silva, PE were initiated in 2013; however, final inspection has not occurred and the building permit was not been closed out (see photos 5 and 6).

Further, repair of water damage to the roof initiated in 2013 is incomplete and the building permit has lapsed without a final affidavit from the engineer of record. Timely implementation of repairs and regular maintenance of the building envelope are essential in extending the serviceable condition of the building structure as it was originally constructed.

5) Incomplete roof repairs on the north side

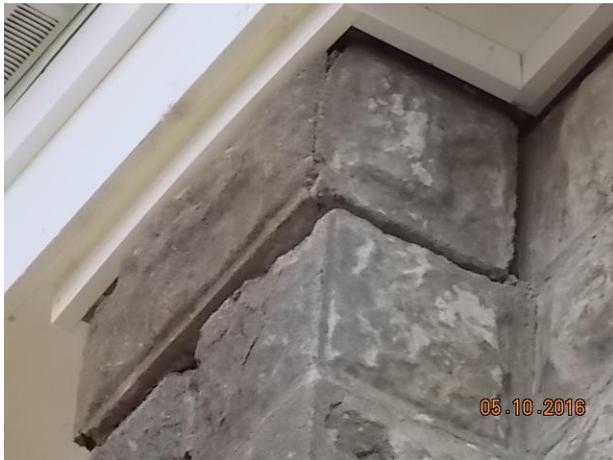
6) Masonry pilaster gapped and misaligned
